PROPOSED WRECK REMOVAL TECHNIQUES

MV “RENA”, WRECKED ON ASTROLABE REEF

AS CONTAINED IN THE OWNER’S RMA APPLICATION

Our Ref: 5750/LOCS/NEH/R006

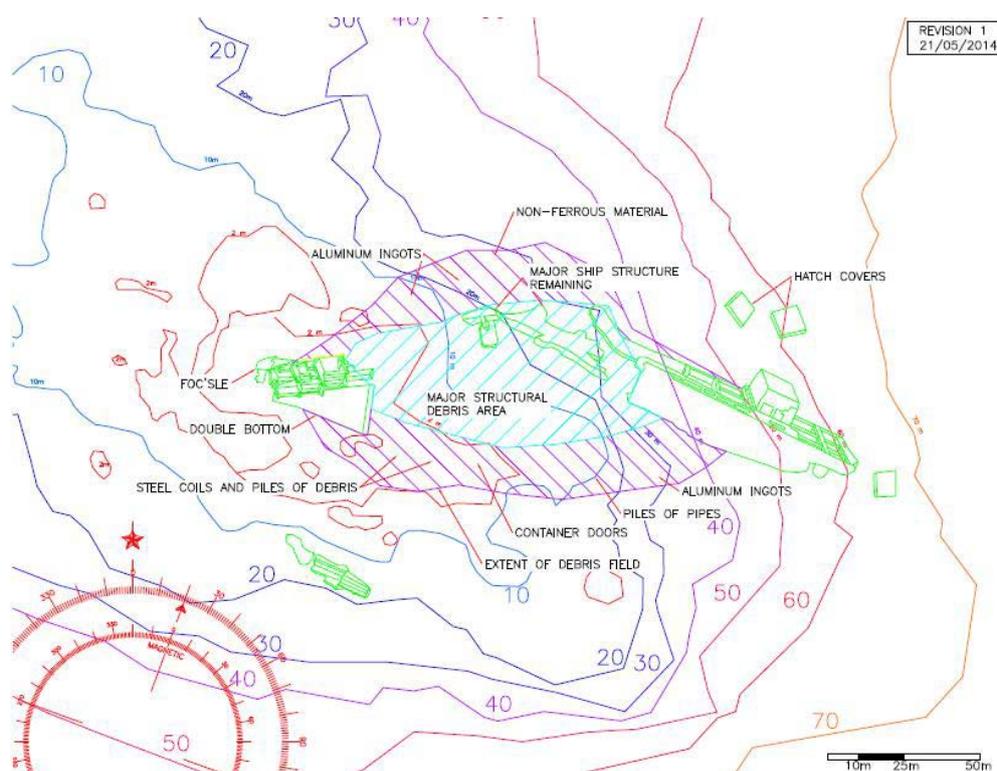
3.2.9 “**Removal of Debris from Debris Field**” is discussed at Sub Paragraph 5.6, Section A of the BECA report. The debris field is described as being in two main areas as shown in *Figure 1* below. The major debris field is stated as between the bow section and the aft section and originally comprised of the bulk of the contents of Hold 3 with structural debris from the wreck. Beyond this is what is termed a minor debris field containing cargo and remnant ship material. The debris field (and the wreck) is said to occupy approximately one hectare (10,000 sq.m) of the Reef and extends down to about -40 metres.

Figure 1. RSF Debris Field Survey April 2014.

It is noted in Table 2 (in Part A, Section 3.1) of the BECA report that in April 2014 that a survey of the entire wreck and debris field was conducted, by ADUS⁸, using advanced multi-beam echo-sounder technology, subsequent to the latest wreck shift resulting from cyclone LUSI. The full results of the ADUS survey detailing the debris field are not included in the resource consent application. However, it is noted that in the “**MV RENA: IMPLICATIONS OR RECREATIONAL DIVING AFTER CYCLONE LUSI –**

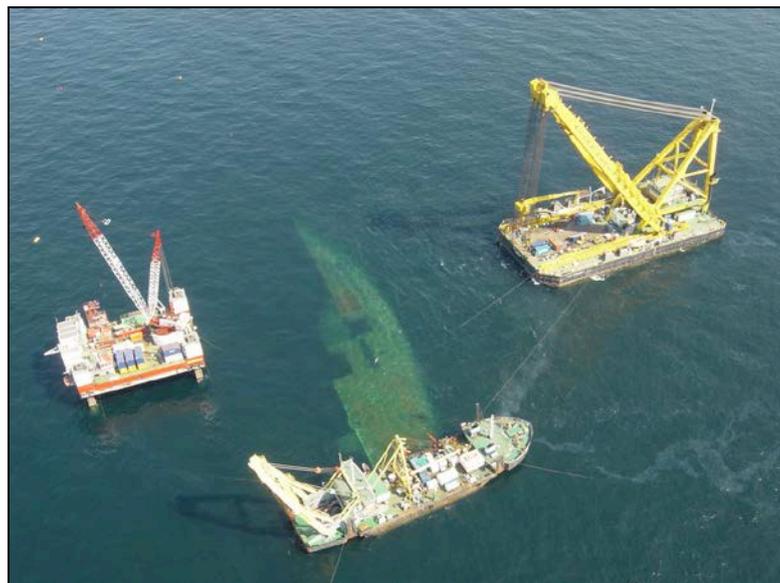
The photographs at Figures 3 and 4 below show the operation. Figure 3 shows a jack-up barge and a sheerleg positioned either side of the wreck, these were used to drill under the wreck and place the cutting wires and then used to cut the wreck into sections. Figure 4 shows two large sheerlegs being used to place the second lifted section on to the barge for transportation to Zeebrugge.

Figure 3: Sheerleg and Jack-up cutting the wreck

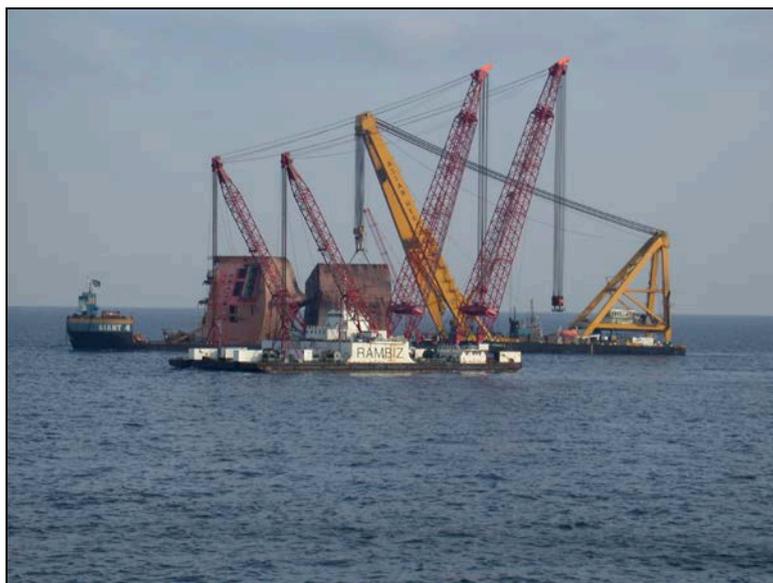
Figure 4: Sheerlegs lifting the second cut section

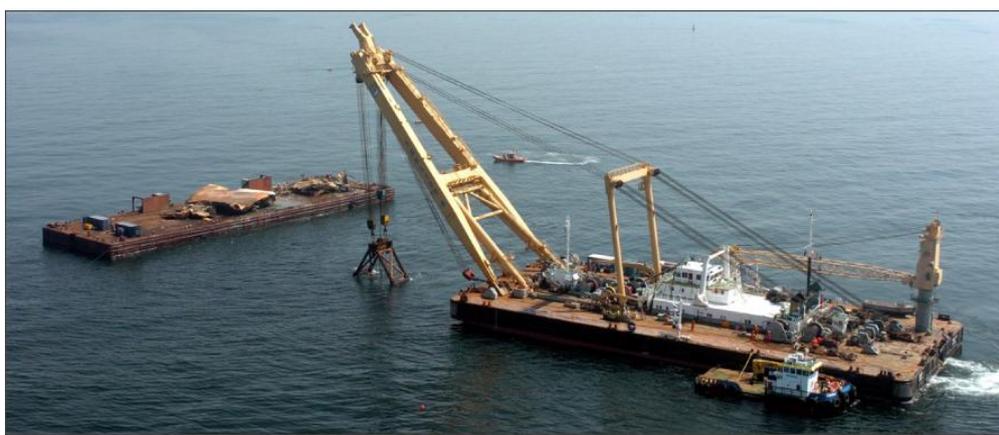
The photograph below at Figure 5 shows a giant wreck grab that was used in conjunction with one of the sheerlegs to remove very large sections of wreckage from the wreck and debris field. This equipment was used after the main wreck sections had been lifted.

Figure 5: Giant wreck grab in use

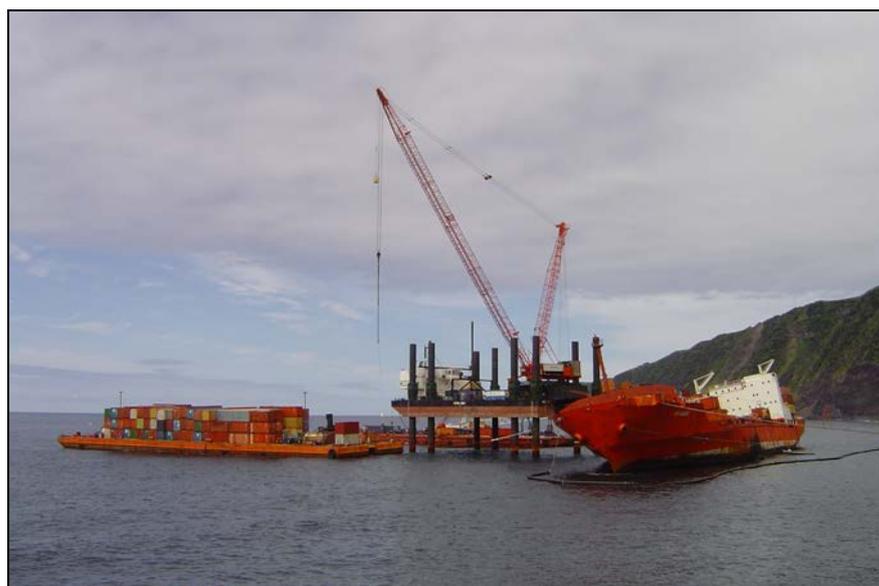
Figure 6: Jack-up barge removing cargo from the wreck

Whilst the above photograph at Figure 6 gives the impression that this was a benign area, this in fact is somewhat misleading. The methodology was

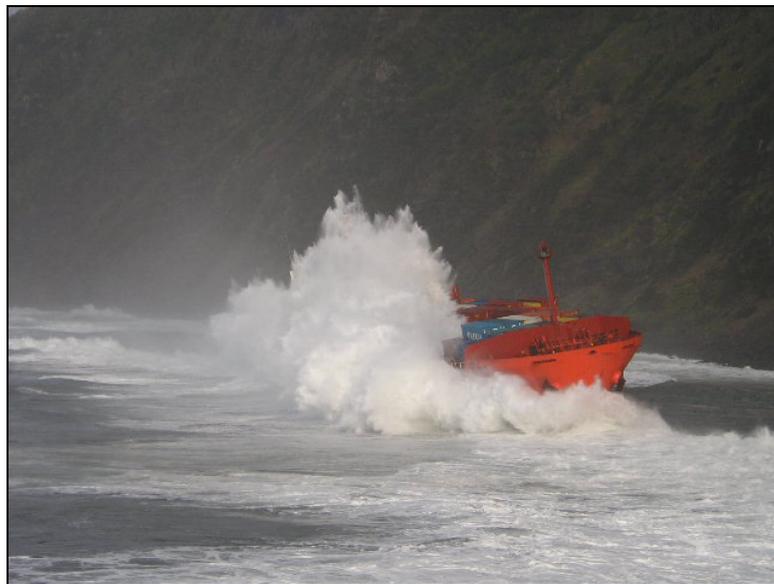
selected considering the vagaries of the weather at this location and Figure 7 below shows conditions often experienced at the site.

Figure 7: Exposed location of the grounding site

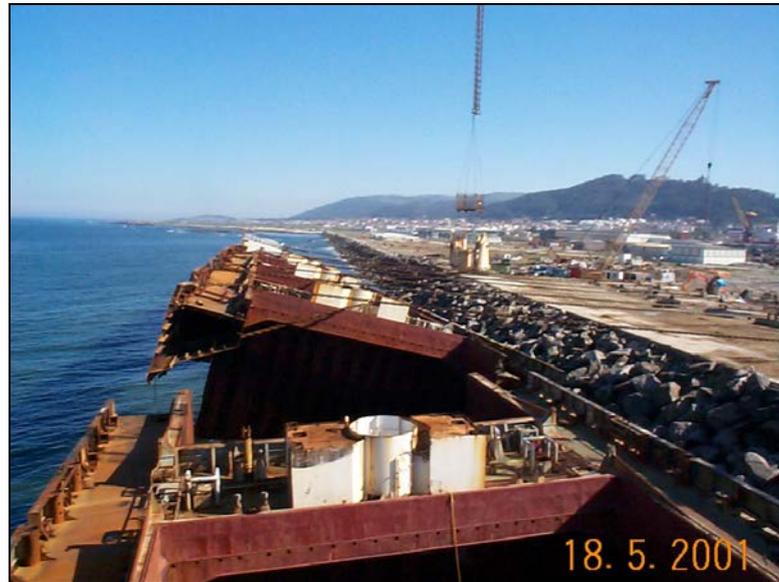
Figure 8: Fore Part of the Wreck during early stages of Parbuckle operation

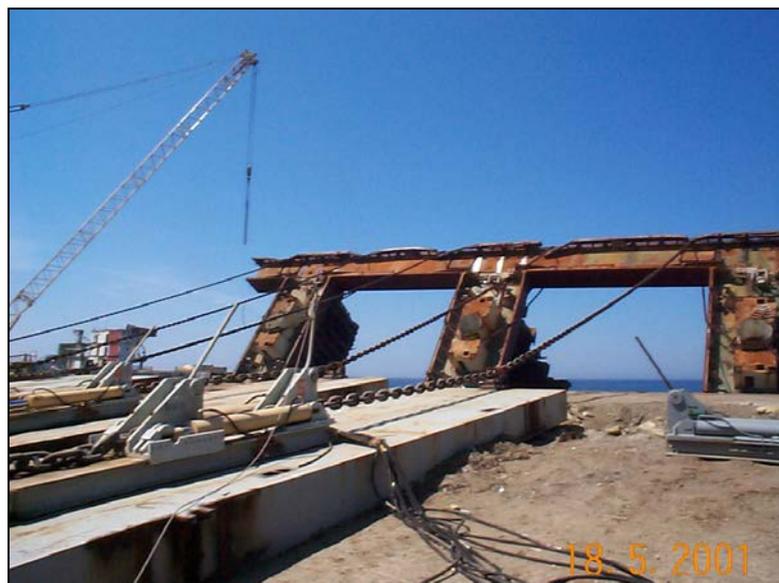
Figure 9: Fore Part of the Wreck showing chain pullers on shore

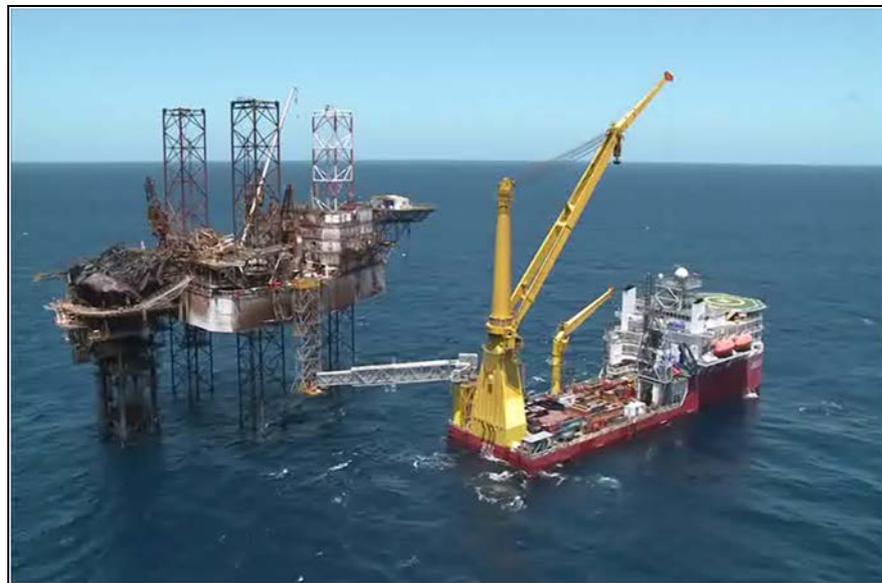
The photograph below at Figure 10 below shows the JASCON 25 in DP mode alongside the MODU and wellhead platform.

Figure 10: JASCON 25 in DP Mode next to MODU WEST ATLAS

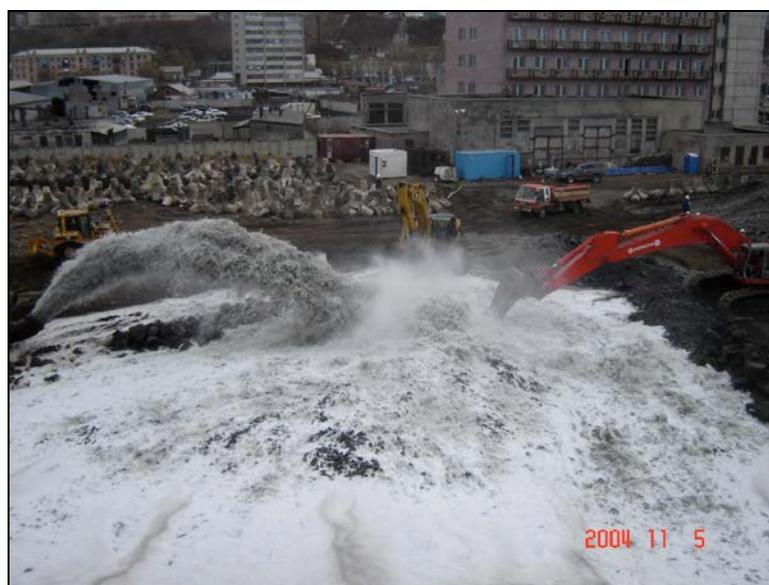
The photographs at Figures 11 and 12 below show the extent of the dredging operation. In addition the second the dredger can be seen at the sea side of the wreck cutting the access channel. The photograph shows how close they operation was to completion prior to the second storm which destroyed the bund and back-filled the channel.

Figure 11: Rock cuttings being pumped ashore to construct the bund

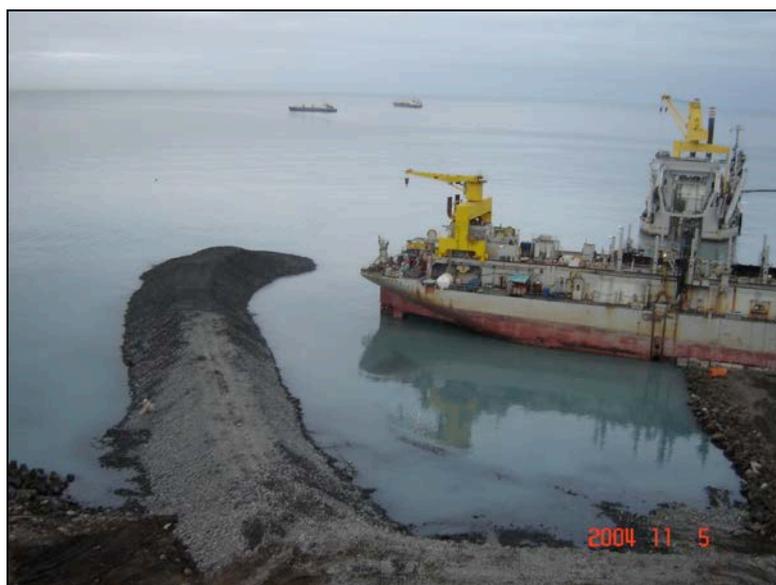
Figure 12: Rock cutting dredger in background

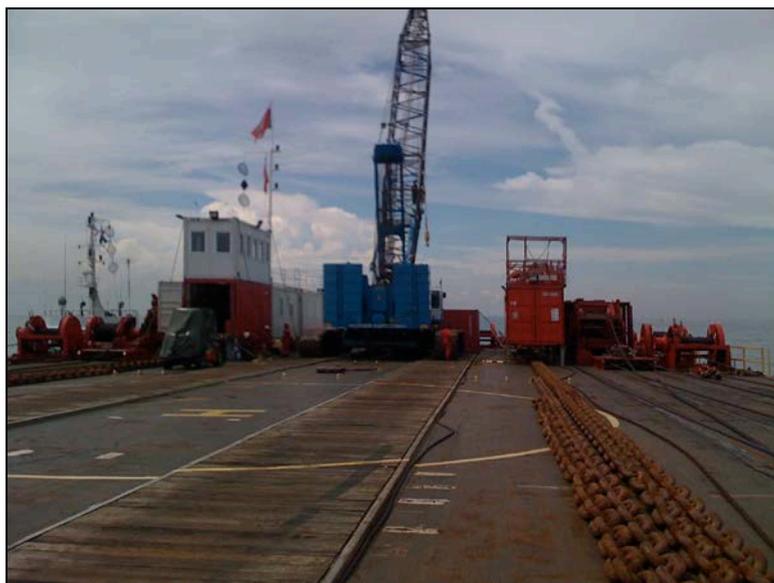
The photograph at Figure 13 below shows the barge deck arrangement, including winches, sheaves and cutting chains.

Figure 13: Mammoet specialist cutting barge

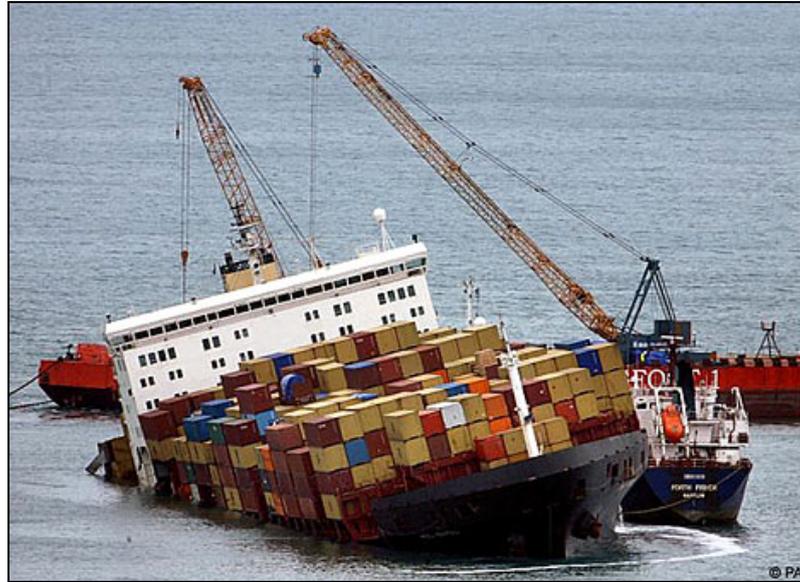
Figure 14: Container removal from MSC NAPOLI

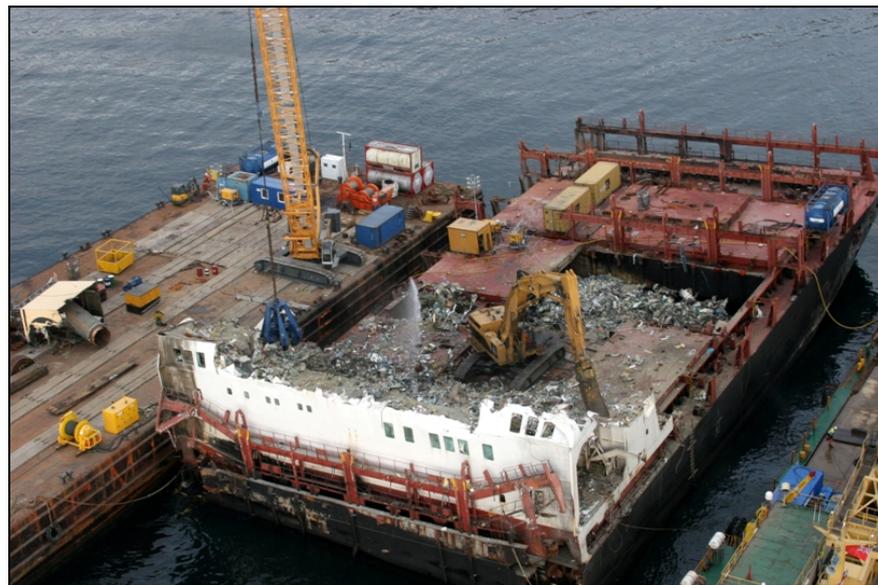
Figure 15: MSC NAPOLI Stern section jacked up between two barges
