**REPORT ON THE**

**NAVIGATION SAFETY ASSESSMENT**

**MV “RENA”, WRECKED ON ASTROLABE REEF**

**Our Ref: 5750/LOCS/NEH/R005**

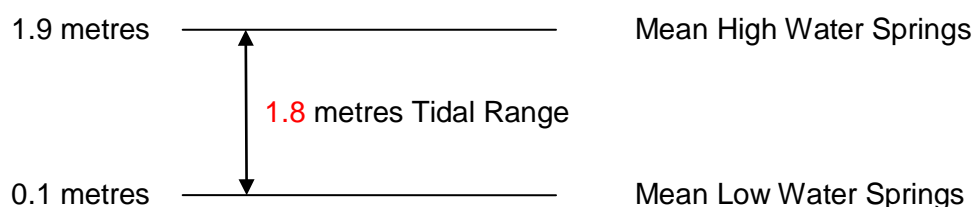
3.3.3 This report comments on the seven sections of the original cut-down forward section. The report advises at *para* 2.5.2 (page 18 of 22) that the starboard side structure (the highest point on the section after cut-down) was now at 3 metres below the waterline. It should be noted that the report advises 3 metres below the waterline and not at -3 metres LAT, no reference is made as to the state of tide at the time the assessment was made. In assessing the potential depth of water above the wreck the height of tide should be considered.

If reading taken at High Water;  $3.0 - 1.8 = 1.2$  metres (minimum at low tide)

If reading taken at Low Water;  $3.0 + 1.8 = 4.8$  metres (maximum at high tide)

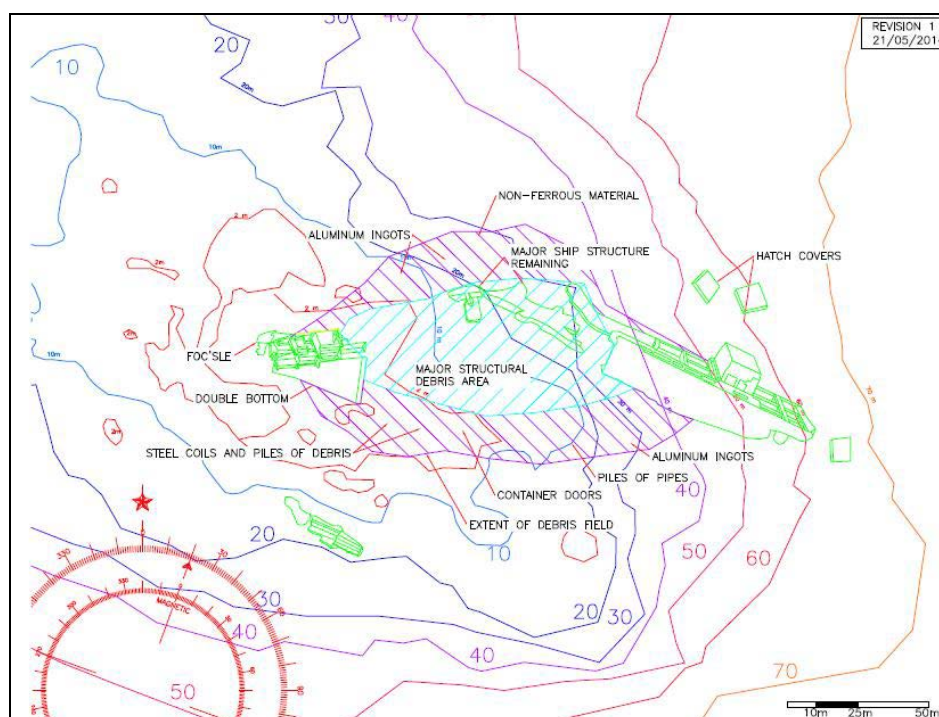
Figure 1. RSF Debris Field Survey April 2014.

- 3.3.8 Under the heading, **Debris Field**, It explains how the debris field covers about 1 Ha, extending between the two sections of the wreck; bow and stern. It then states that ***“The shallowest part of the debris field is at approximately 8 metres depth. This depth has remained relatively constant since the wreck split in January 2012.”*** Firstly, in the drawing of the debris field included in the BECA report (**APPLICATION FOR RESOURCE CONSENT (MV RENA) – Background and Consideration of Alternatives – Volume Three**” prepared on behalf of the owner of M.V. **“RENA”** by Beca Carter Hollings & Ferner Ltd (BECA) dated 27th May 2014), see Fig. 1 below, the debris field is shown to extend from the bow double bottom through the areas bounded by the 2m depth contour.
